## REPORT OF FINDINGS

PURDUE UNIVERSITY  
ELECTRICAL VAULT  
INVESTIGATION

File No: 5840607

Prepared For:  
**STUART & BRANIGIN**

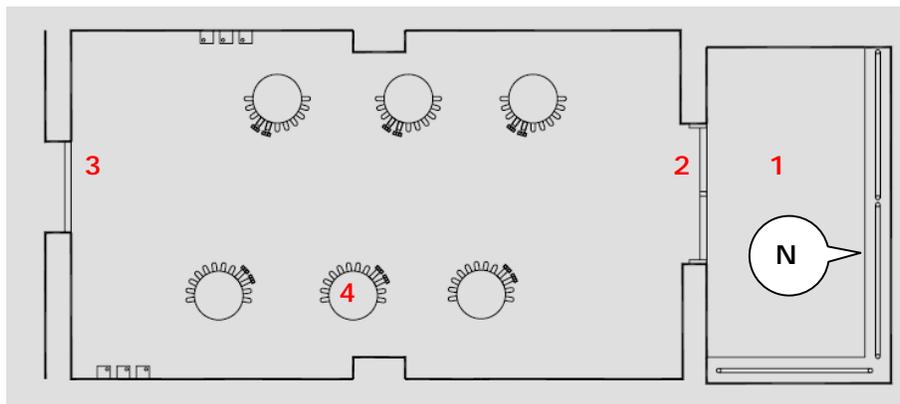
Plan view of electrical vault

1. Wade Steffey entered the electrical vault through the exterior door on the north side of the room.
2. The configuration of the exterior entrance to the electrical vault was obviously not intended for access to the building by residents or the public.
3. The concrete walls and metal railing surrounding the pit did not prevent Wade Steffey from gaining access to the electrical vault door.
4. The exterior door to the electrical vault was most probably unlatched and/or unlocked at the time of Wade Steffey's entrance.
5. In the condition cited in #4 above, the exterior door did not prevent entrance by Wade Steffey.

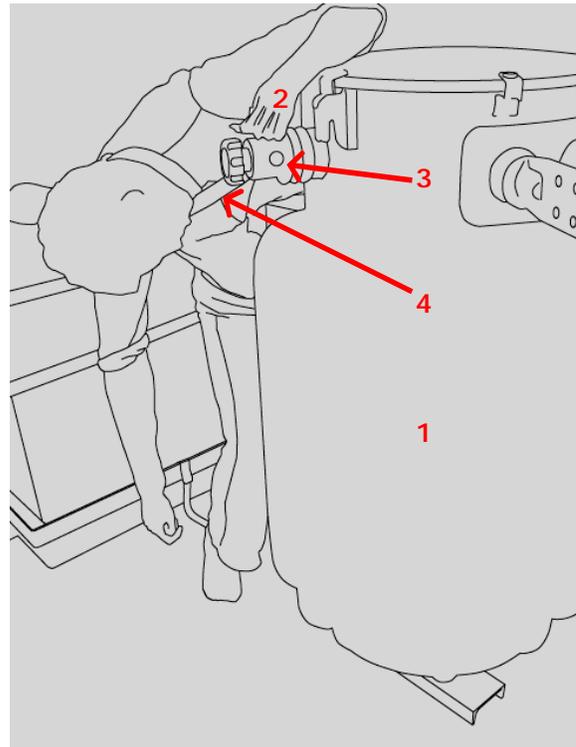
View of transformer 2 looking southeast

The body of Wade Steffey was found in the transformer vault of Owen Hall on March 19, 2007. When his body was found, his shirt had brown dust/dirt on it and a red stain on the front, he was not wearing shoes, there was a tear noted on the back of the shirt near the right shoulder, and his belt was half twisted (worn incorrectly, such that the back of the belt was facing forward when inserted into the buckle). The body was found behind the middle transformer along the east wall of the transformer vault, and was facing north.

His body was positioned such that the transformer was to his left, three routing electrical cables attached to the wall via standoffs were to his right, a cable running from one of these routing electrical cables to the transformer at about thigh to chest height was behind him, and another cable from the routing electrical cable to the transformer at about chest height was in front of him. The body was found draped over the north cable and transformer, with the left hand positioned just above the bushing that attaches this cable to the transformer.

The area where he was found was about 13.5 inches at its narrowest (between the transformer and the 3 cables attached to the wall) and about 2 feet between the north and south cables. The hole in the bushing had a diameter of 0.88 inches.

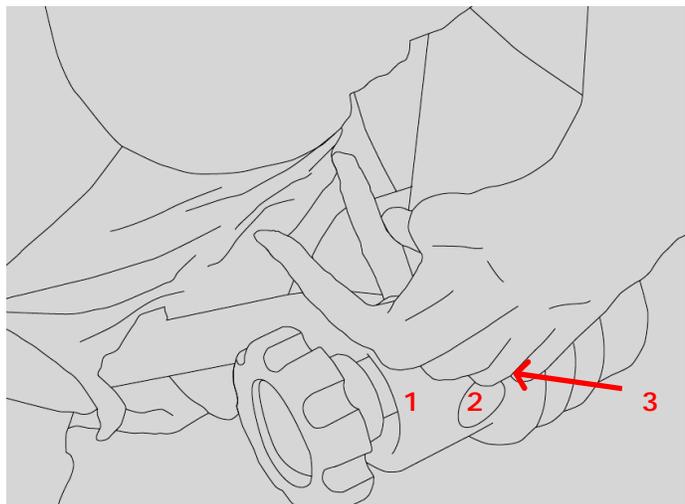
View of ceramic bushing and left hand

As mentioned in Section III, the north bushing on Transformer 2 showed signs of physical contact on the exposed end of the conductor. The other eleven bushings on the transformers did not have any indication of physical contact. Also, his left ring-finger, described as the electrical entrance point in the autopsy, was found directly above this bushing.

The hole that led to the exposed end of the connector had a diameter of 0.88 inches, which is larger than the diameter of the tip of the ring finger on a 70 inch tall, 150 pound male. All of the physical evidence, along with the autopsy report, indicates that this was the point of electrocution.

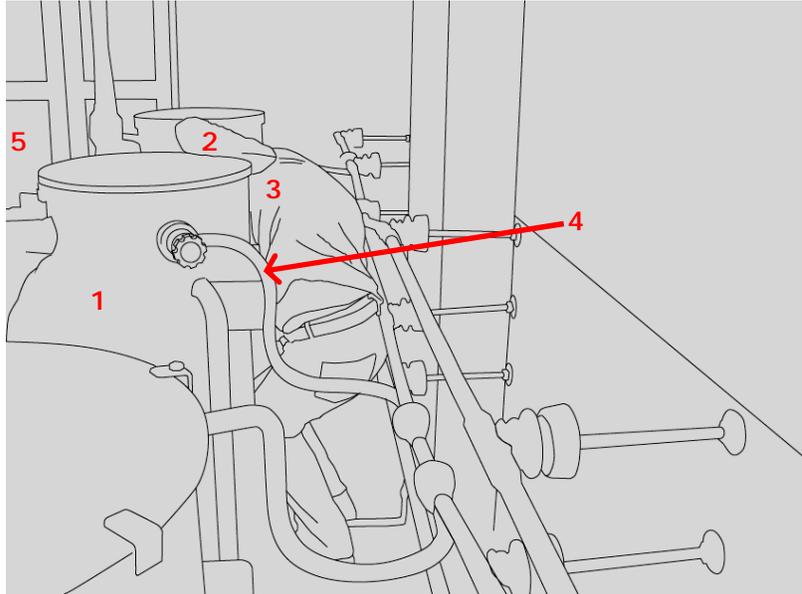
View of electrical Vault Looking North toward Northeast corner

Dust disturbances on the top of the transformer and surrounding areas indicate

that he did not come from on top of the transformer. To come from the north side he would have had to squat down and contort himself underneath the cable that ran from the transformer to the wall while facing away from the transformer. While this would have been possible to do, it would have been quite difficult, and this difficulty would be exacerbated by intoxication. Once positioned behind the transformer, Wade Steffey placed his hand on the northern bushing, with his ring-finger contacting the exposed conductor leading to electrocution.
