Worker Hazards Associated with the Use of Grain Vacuum Systems

W. E. Field, D. J. Heber, S. M. Riedel, S. W. Wettschurack,
M. J. Roberts, L. J. Grafft

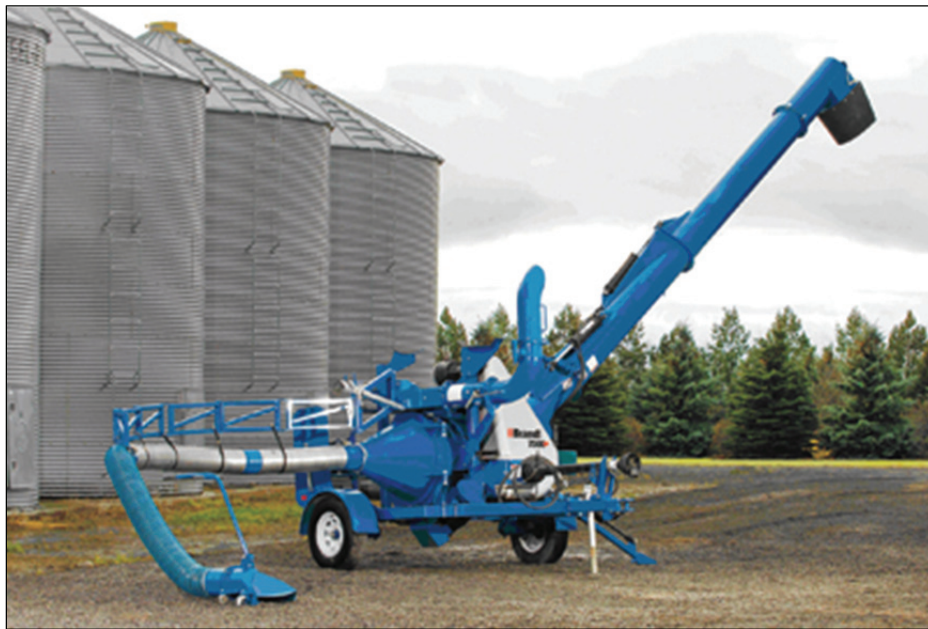
Figure 1. PTO-operated grain vacuum machine.

Grain vacuums are available with one of three power sources: tractor-operated power takeoff (PTO), engine-mounted units, or electric motor. Portable, tractor-operated PTO systems are the most common (fig. 1) for farm applications with capacities of 8.8 to 52.9 m³ h⁻¹ (250 to 1,500 bu h⁻¹). Some larger commercial facilities use grain vacuum machines that are capable of moving grain at rates between 52.9 and 352.4 m³ h⁻¹ (1,500 and 10,000 bu h⁻¹), depending on the power source and grain type. Salvage operations may use truck-mounted or semi-stationary units. These systems operate at power levels from 74.6 to 134.2 kW (100 to 180 hp). Grain vacuum systems generally contain the following primary components: a power source, intake pipe, intake air valve, discharge pipe, blower, air lock, and cyclone separator (fig. 2). Intake hoses are made of various materials, including solid and flexible metal tubing and rigid rubber hoses. The blower provides suction and discharge, drawing grain in through the intake hose and discharging it through the air lock and cyclone separator. The cyclone separates the grain from the air and pushes the grain out through the discharge pipe. Manufacturers produce variations of

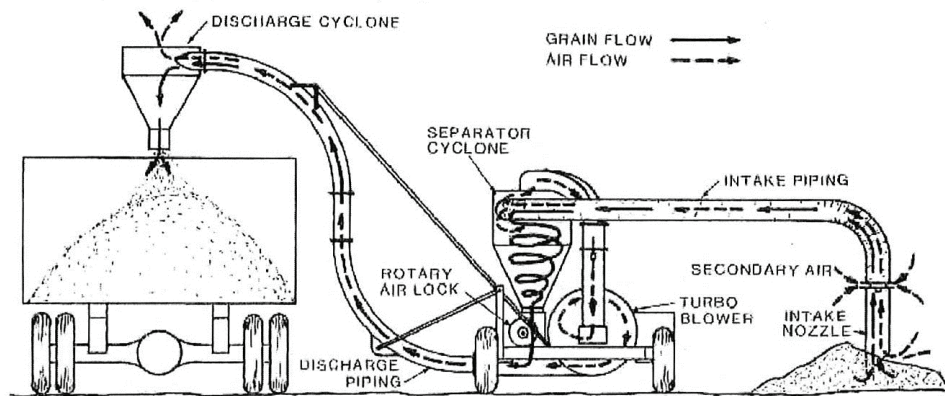
Figure 2. Schematic of pneumatic conveyor showing air and grain flow (Atkins and Wiens, 1982).

these systems; for example, some do not use a cyclone separator yet contain the other primary components. Examination of several types of systems currently in use found that some have no means of controlling intake capacity at the inlet, such as a shut-off control or slide valve to allow additional air to enter the intake to reduce the suction.

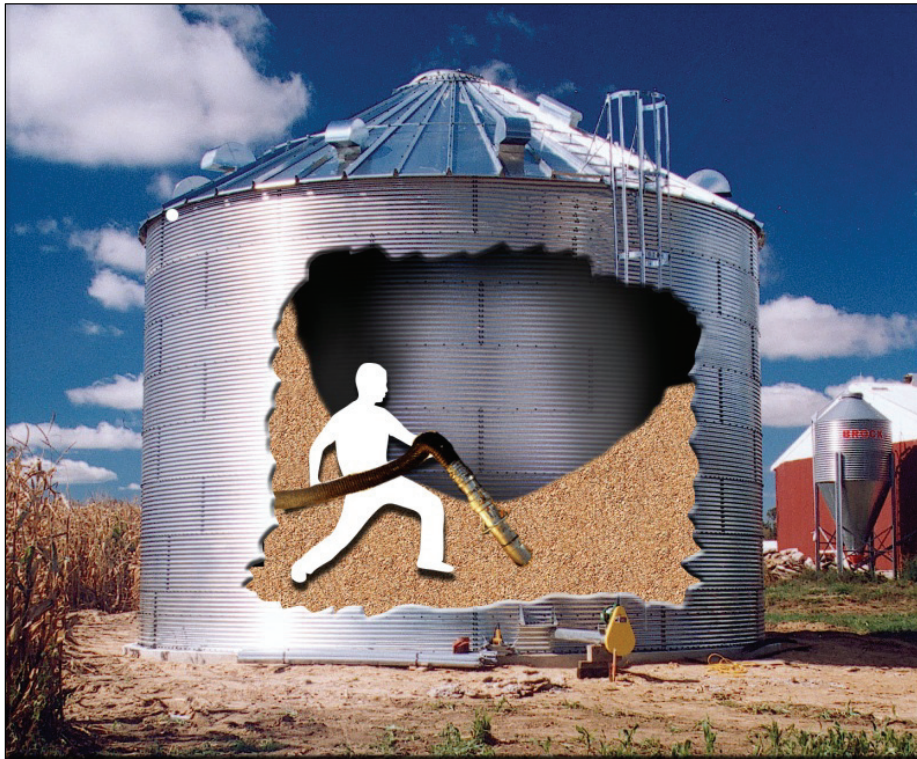
Figure 3. Illustration of a vacuum causing a cone depression in the grain.

During recommended vacuum unloading procedures, the operator moves the inlet frequently to maximize efficiency. However, if the inlet is left long enough in one location, the vacuum can rapidly create a depression that the operator can slip into, and then become entrapped under the inflowing grain or pulled farther down by the grain flow (fig. 3). In one case, an observer watched helplessly from the outside of the bin while a

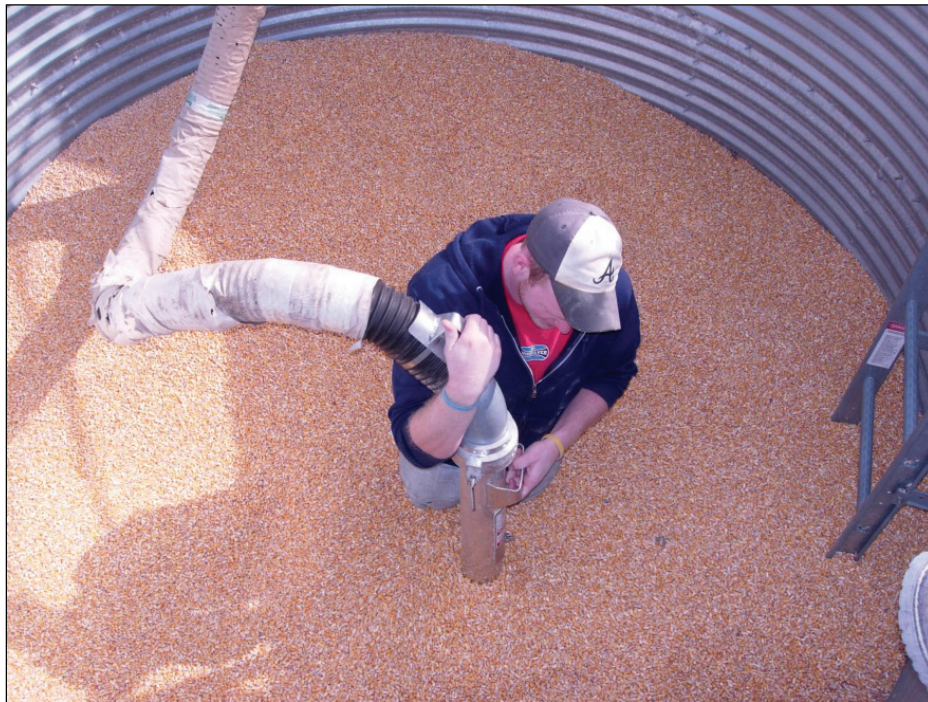
Figure 4. Demonstration of the rate of human entrapment by a grain vacuum system.

To better understand the engulfment process, a test was set up at the Purdue University Post-Harvest Grain Storage Center in which a small bin of corn and a grain vacuum system were used to demonstrate engulfment speed. The bin was an open-top corrugated steel structure used for grain bin rescue demonstrations, and it contained a floor grate to prevent full engulfment of anyone in the bin. The medium used was dried corn at or below 14% moisture. A $42.3 \text{ m}^3 \text{ h}^{-1}$ (1,200 bu h^{-1}) capacity PTO-operated grain vacuum system was used to draw the grain out of the bin using a flexible hose and a hand-operated intake. With the operator standing on the surface of the grain holding the intake, the vacuum system was activated. When the intake was placed at the operator's feet, it took less than 15 s for the operator to be drawn into the grain beyond the point of self-extrication (fig. 4). The speed of entrapment was surprising to both the operator and the observers. However, considering that the vacuum system was removing approximately $42.3 \text{ m}^3 \text{ h}^{-1}$ (1,200 bu h^{-1}) or approximately $0.011747 \text{ m}^3 \text{ s}^{-1}$ ($1/3 \text{ bu s}^{-1}$), the speed of a body, comprised of about 0.07048 m^3 (2 bu) by volume, entering the grain mass should have been anticipated.

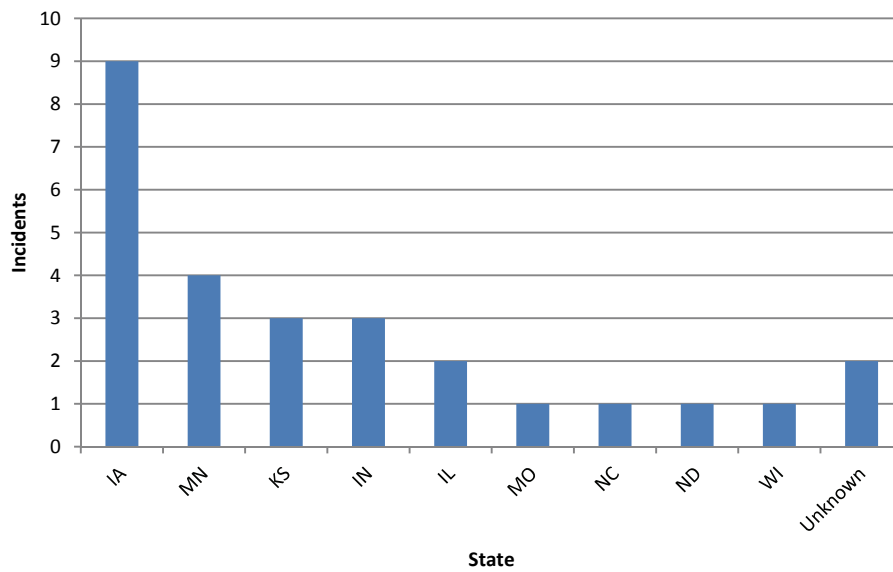
Figure 5. Documented grain vacuum incidents by state.

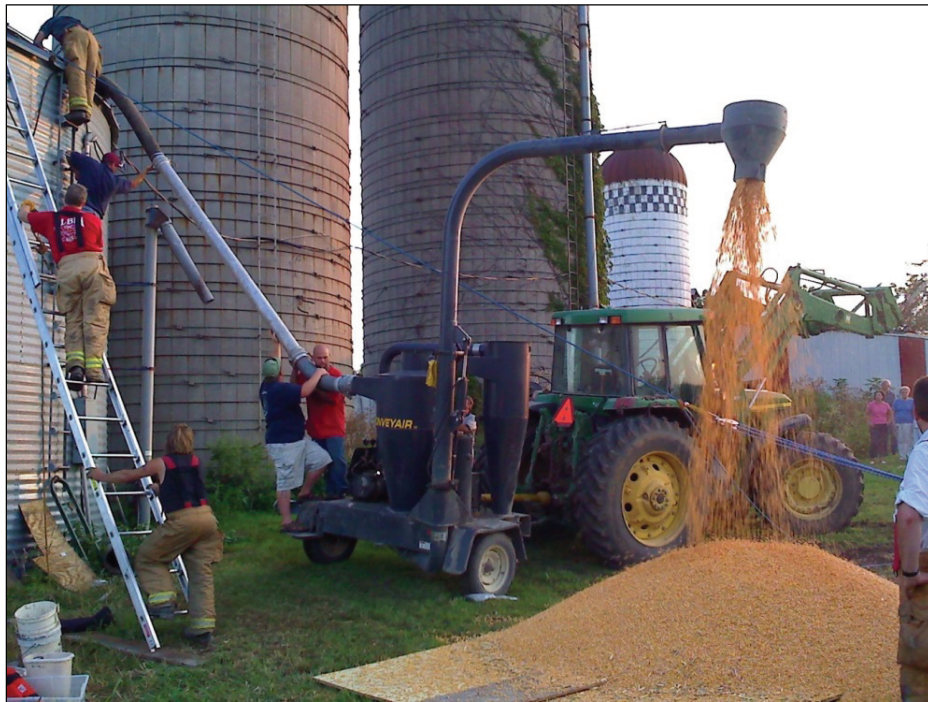
Figure 6. A grain vacuum used in an attempt to rescue a man entrapped in a bin on an Indiana farm.

appropriate grain rescue strategies, including the use of grain rescue containment devices such as grain rescue tubes (figs. 6 and 7). During this training, fire departments and other rescue personnel are instructed to employ grain vacuums to remove grain from within the grain rescue tube and/or to remove grain from the structure to access the victim. The use of vacuums in grain rescue attempts has clearly increased in recent years, most likely due to the greater access to these machines and instruction in their use as a rescue strategy. Only ten rescue attempts involving the use of a vacuum were documented before the year 2000. Since then, 31 vacuum rescue attempts have been documented (fig. 8).

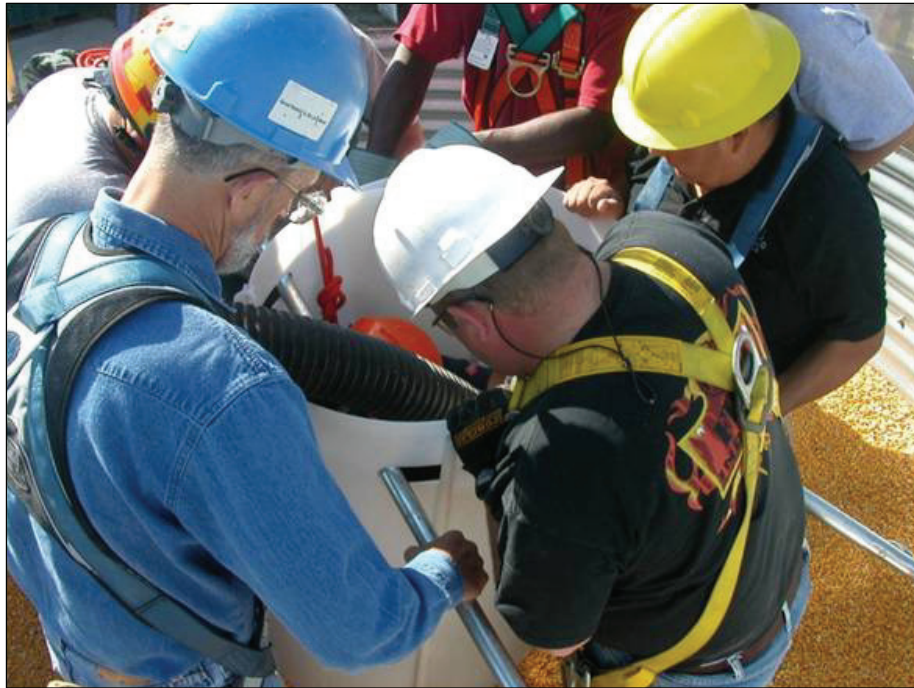
Figure 7. A fire rescue team trains to use a grain vacuum and tube for entrapment rescue attempts.

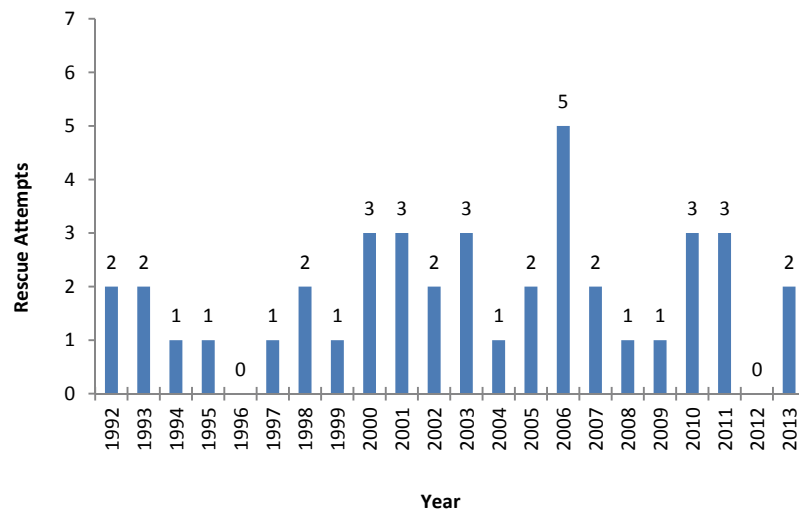
Figure 8. Documented grain vacuum rescue attempts by year.
